**RE: Wanaque River Remedial Investigation Report – Revised July 2011**  
**DuPont Pompton Lakes Works**  
**Pompton Lakes, New Jersey**  
**PI #007411**

Enclosed for your review is the Wanaque River Remedial Investigation Report (RIR) for the Pompton Lakes Works Site located in Pompton Lakes, New Jersey. One bound copy and three CDs each containing a complete set of figures are included herein.

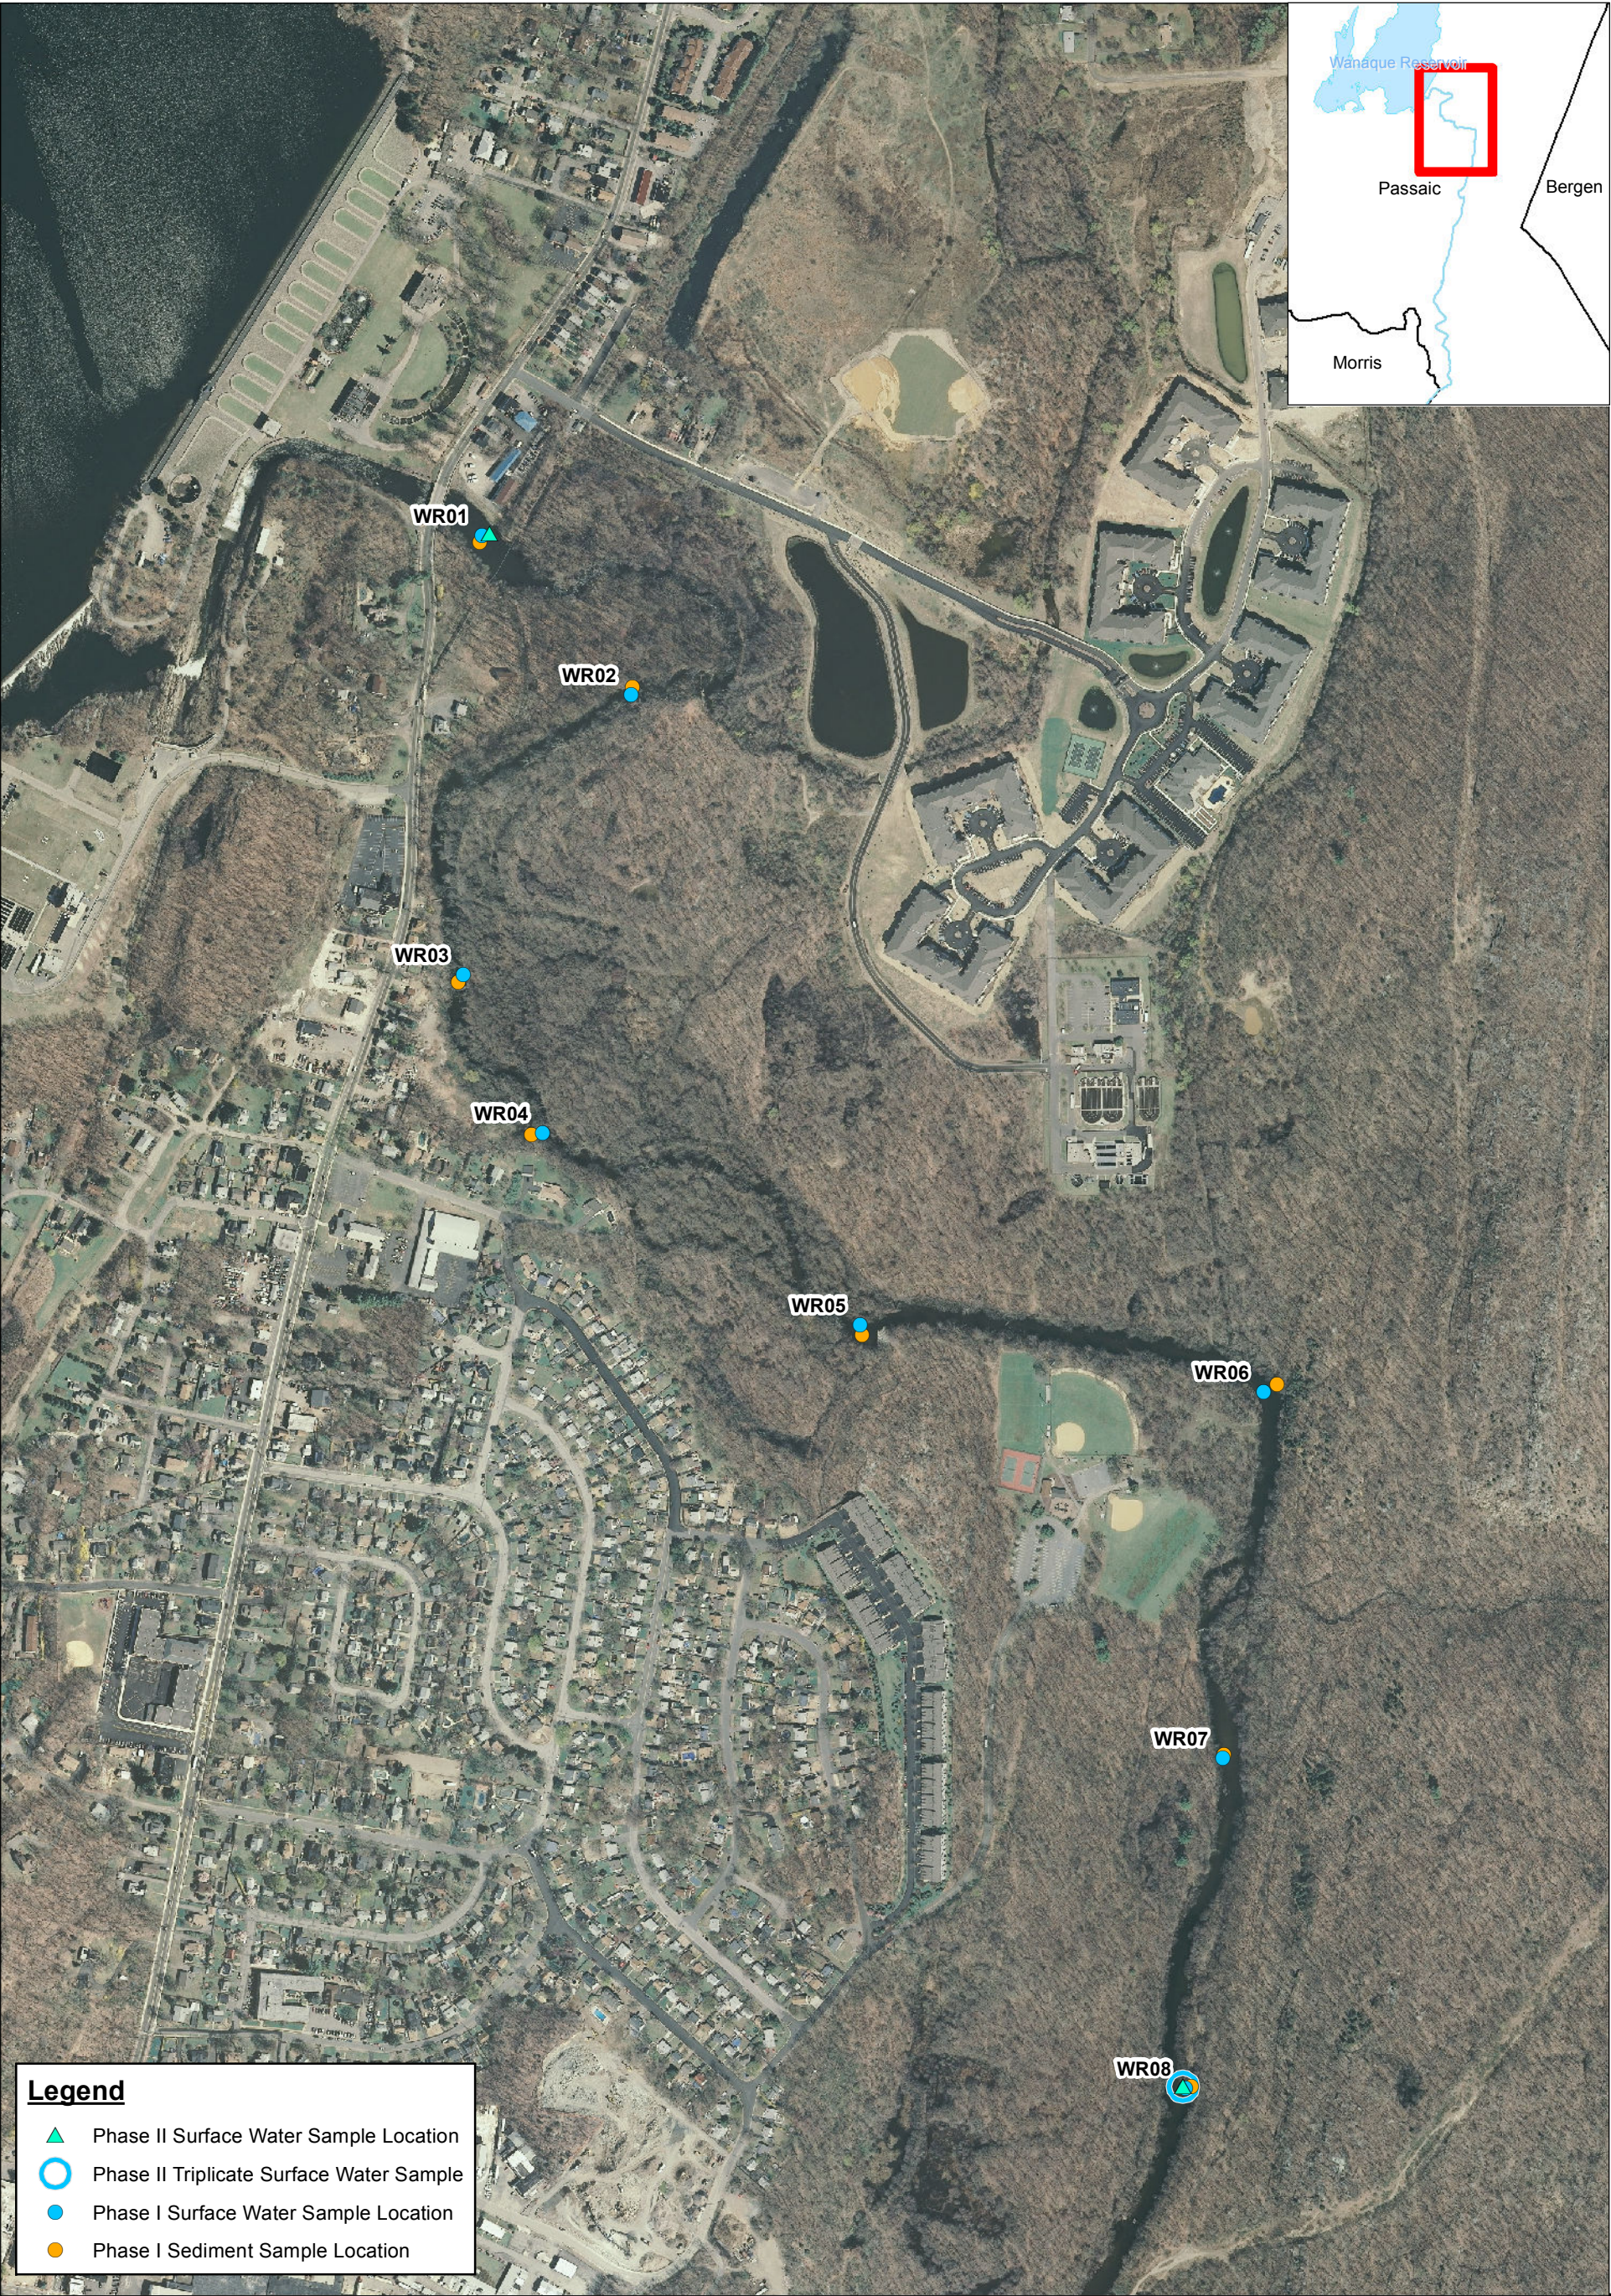
**Figure 5**  
**Reach 1 Sampling Locations - Phases I and II**  
**Wanaque River**  
**Remedial Investigation Report**  
**DuPont Pompton Lakes Works**  
**Pompton Lakes, New Jersey**

- Reach 1: Eight stations were sampled in the upstream reach to provide adequate data for calculating a background concentration in accordance with EPA ProUCL guidance (EPA, 2007; see Figure 5).
- Reach 2: Ten stations were sampled in the reach within the property boundary; sampling stations were distributed throughout, with targeted sampling in depositional features downstream of elevated mercury concentrations found in adjacent floodplain soils (see Figure 6).
- Reach 3: Six stations were sampled downstream of the site property boundary to evaluate the extent of potential downstream COPEC migration. Reach 3 sampling stations were proposed at or near previously sampled sediment stations (see Figure 7).

Twenty-two stations were sampled in Phase II to provide additional characterization of mercury concentrations in surface water. As illustrated in Figures 5 through 7, a subset of these locations was selected for triplicate sampling to provide higher quality data for evaluation by estimating sampling variability. The selection of stations for triplicate analyses was based on sampling stations where step-change increases in filtered and unfiltered THg concentrations were observed during Phase I data collection:

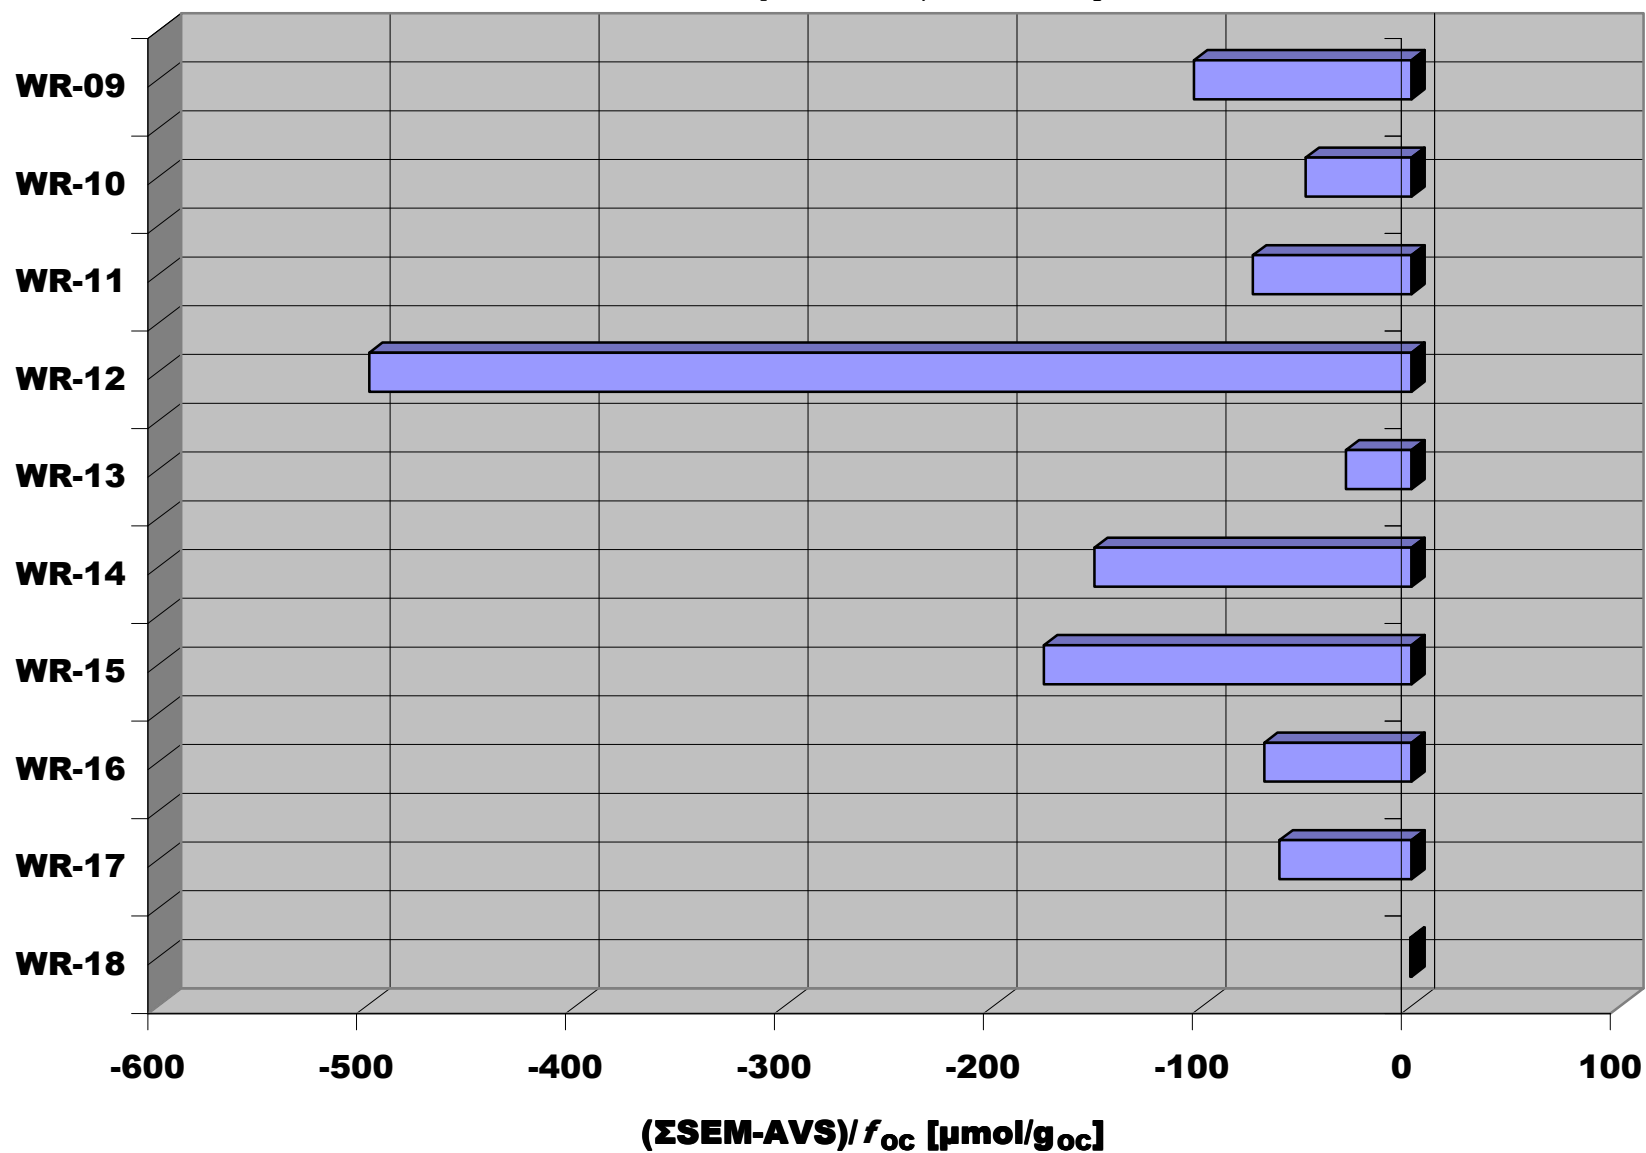
**Figure 4. Bioavailability of Divalent Metals in Reach 2 Sediments**  
**DuPont Pompton Lakes Works**  
**Pompton Lakes, New Jersey**

Note: Low risk of adverse biological effects when  $(\Sigma\text{SEM-AVS})/f_{oc} < 130 \mu\text{mol/g}_{oc}$

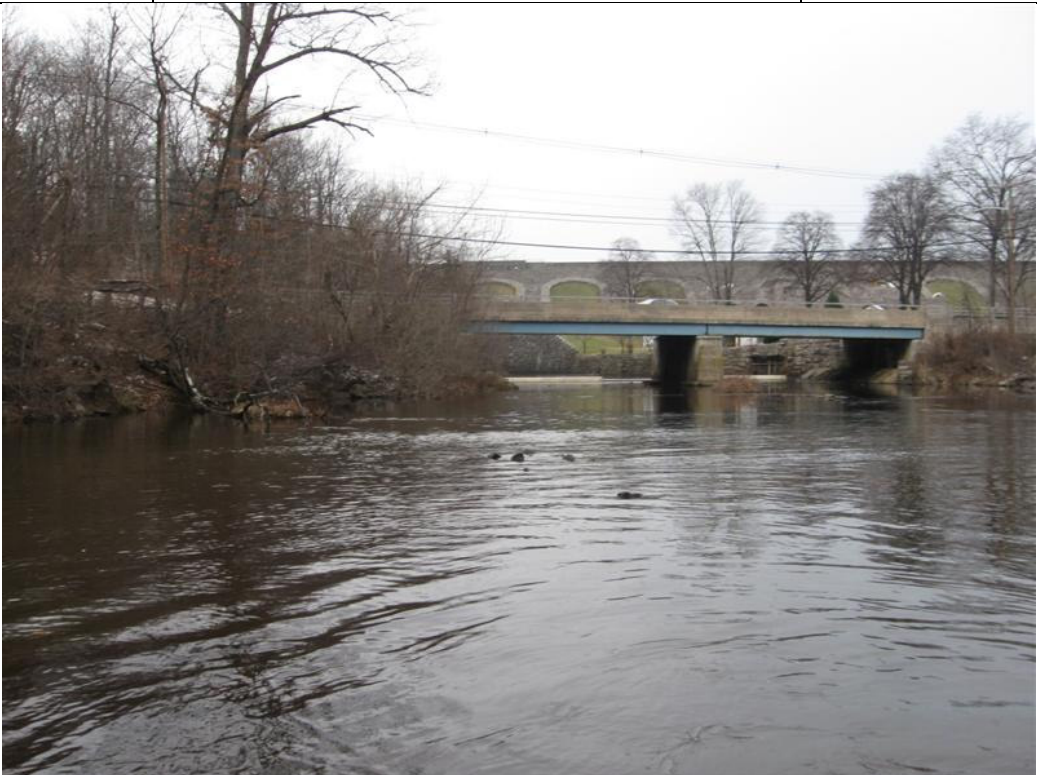
<b>Client Name:</b> DuPont		<b>Site Location:</b> Wanaque River Valley	<b>Project No.</b> 18985452
<b>Photo No.</b> 1	<b>Date:</b> 12/07/2009

<b>Direction Photo Taken:</b> Northwest			
<b>Description:</b> Sampling location WR-01

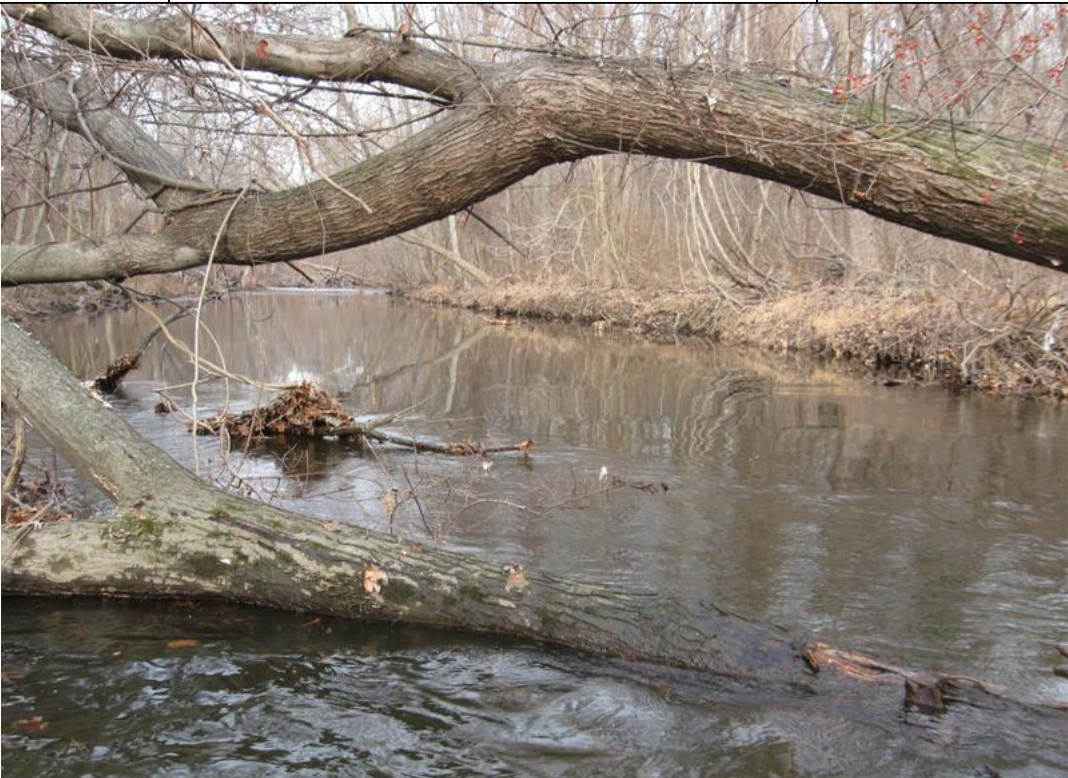
<b>Client Name:</b> DuPont		<b>Site Location:</b> Wanaque River Valley	<b>Project No.</b> 18985452
<b>Photo No.</b> 3	<b>Date:</b> 12/07/2009

<b>Direction Photo Taken:</b> North			
<b>Description:</b> Sampling location WR-03

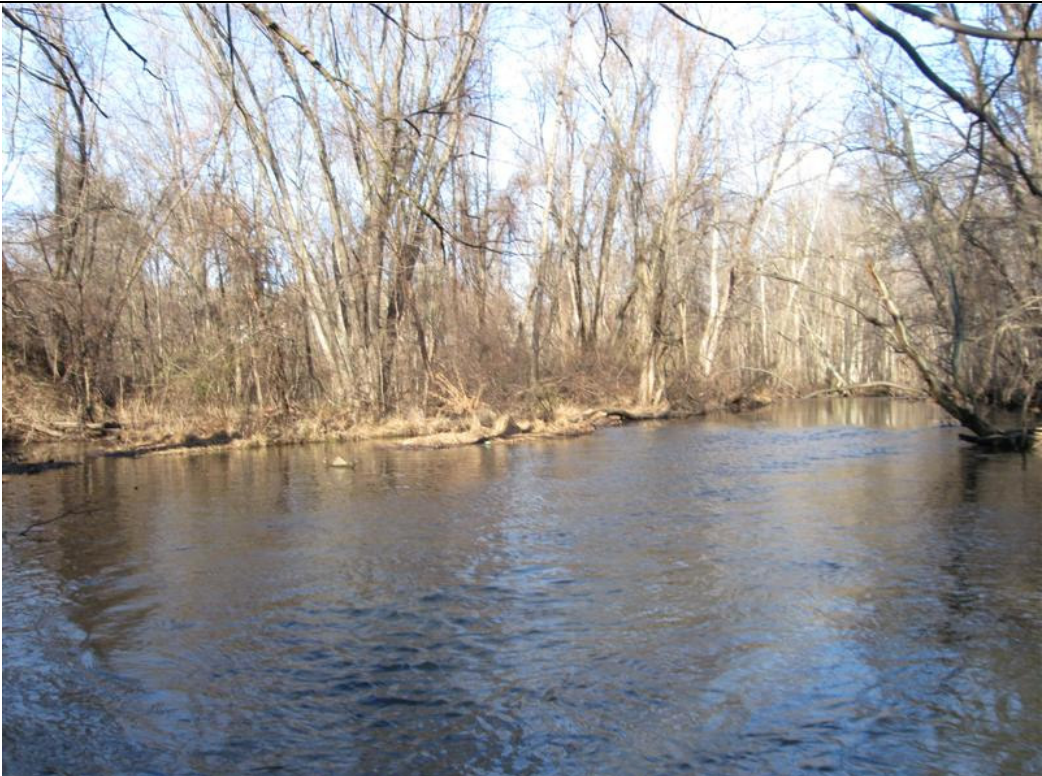
<b>Photo No.</b> 4	<b>Date:</b> 12/16/2009

<b>Direction Photo Taken:</b> North		
<b>Description:</b> Sampling Location WR-04

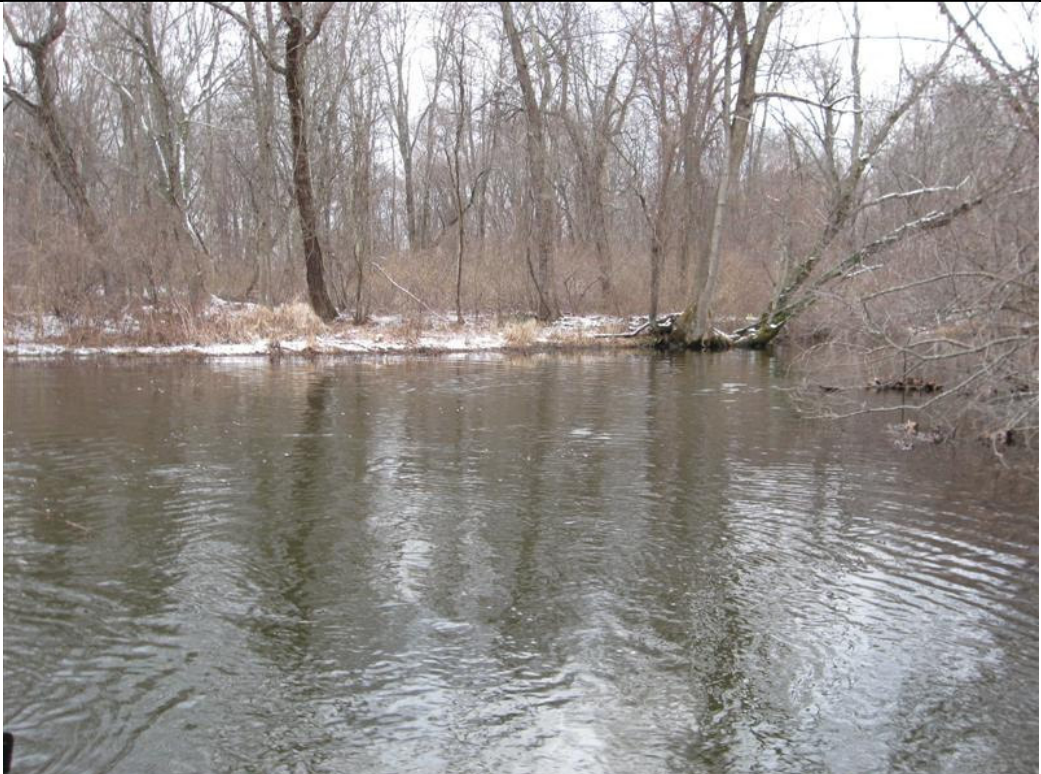
<b>Client Name:</b> DuPont		<b>Site Location:</b> Wanaque River Valley	<b>Project No.</b> 18985452
<b>Photo No.</b> 5	<b>Date:</b> 12/07/2009

<b>Direction Photo Taken:</b> West			
<b>Description:</b> Sampling location WR-05

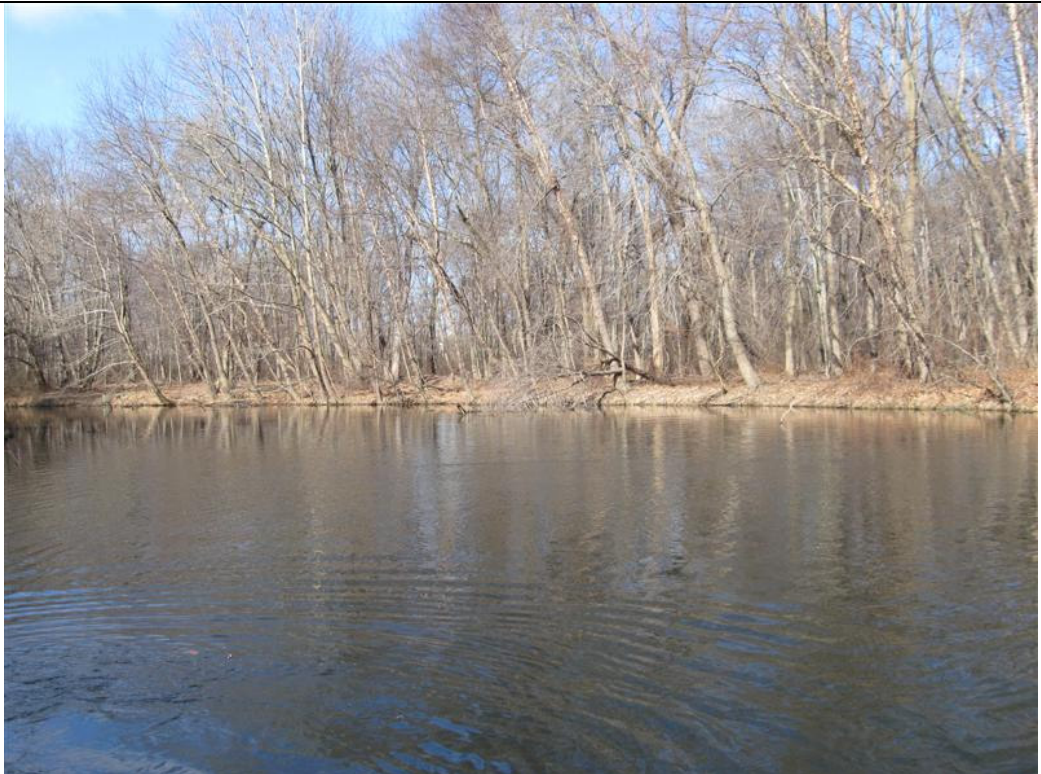
<b>Photo No.</b> 6	<b>Date:</b> 12/16/2009

<b>Direction Photo Taken:</b> North		
<b>Description:</b> Sampling Location WR-06

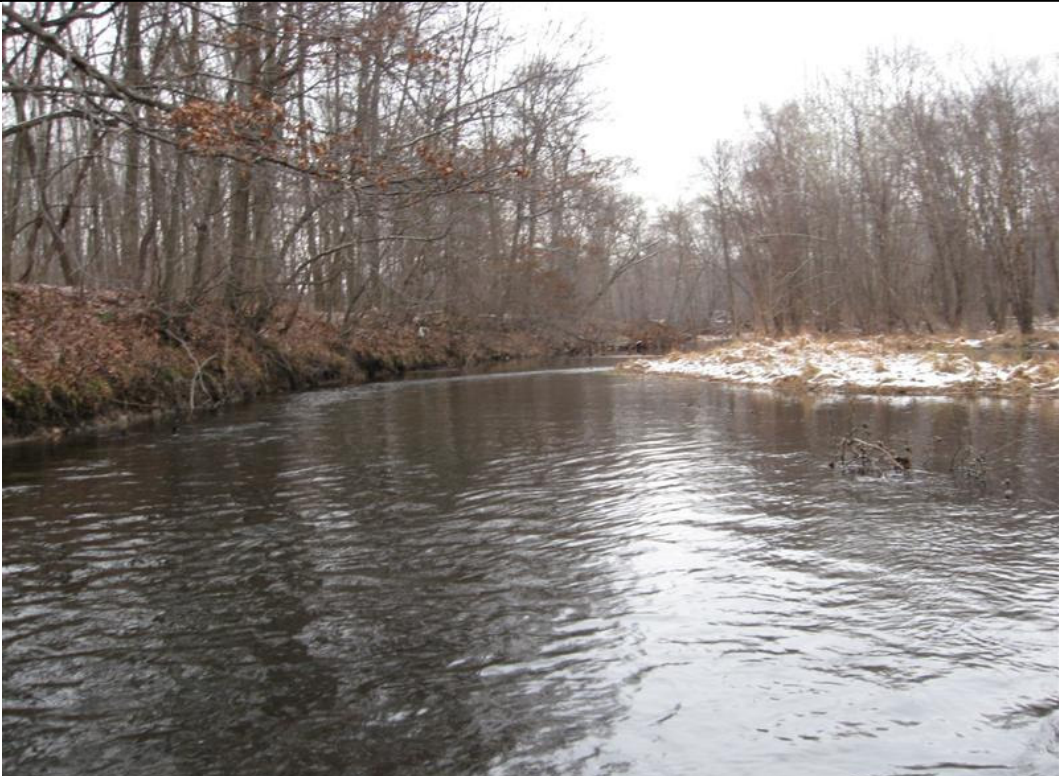
<b>Client Name:</b> DuPont		<b>Site Location:</b> Wanaque River Valley	<b>Project No.</b> 18985452
<b>Photo No.</b> 7	<b>Date:</b> 12/07/2009

<b>Direction Photo Taken:</b> North			
<b>Description:</b> Sampling location WR-07

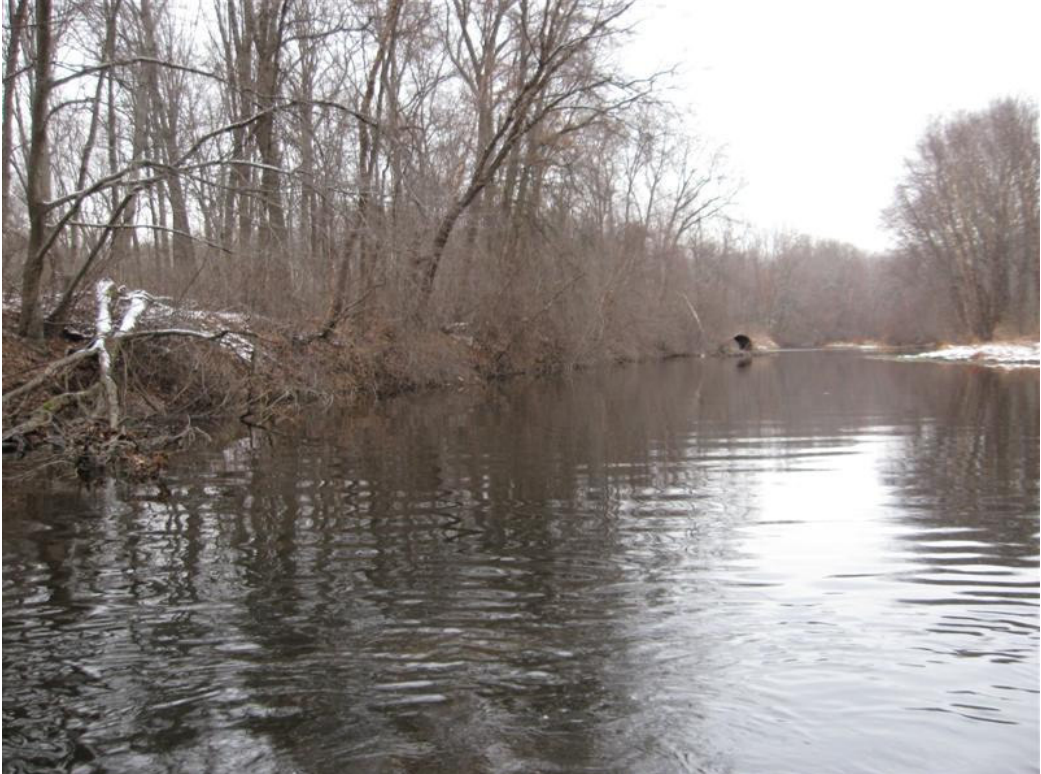
<b>Client Name:</b> DuPont		<b>Site Location:</b> Wanaque River Valley	<b>Project No.</b> 18985452
<b>Photo No.</b> 9	<b>Date:</b> 12/07/2009

<b>Direction Photo Taken:</b> North			
<b>Description:</b> Sampling location WR-09

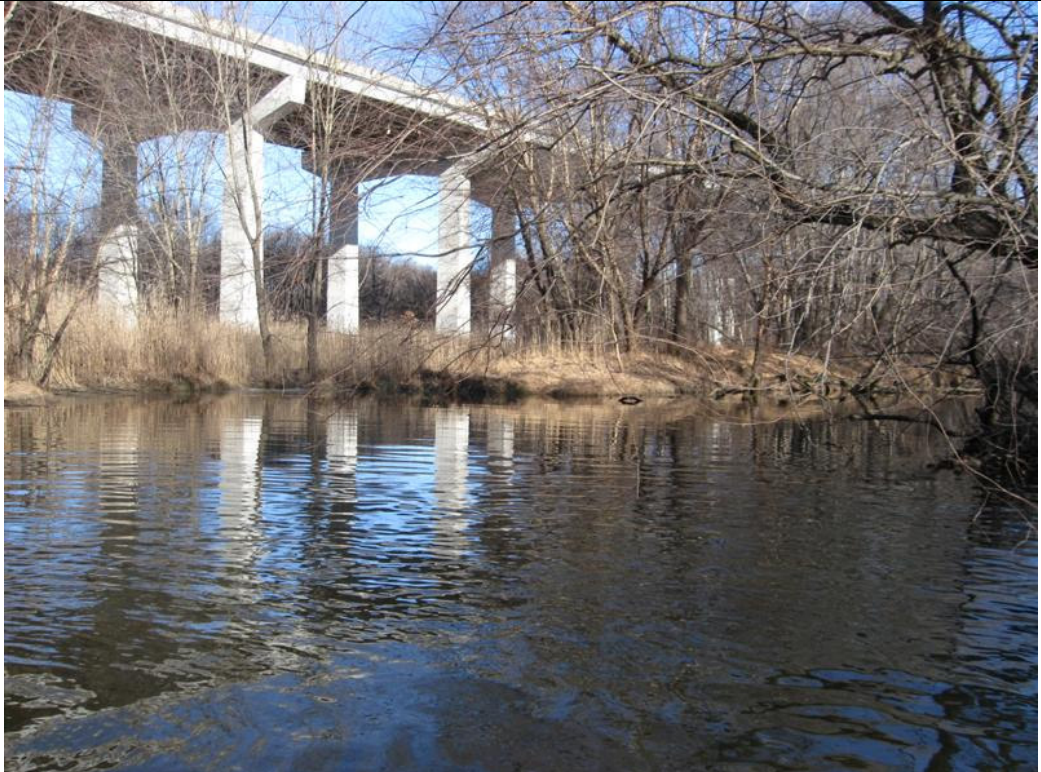
<b>Photo No.</b> 10	<b>Date:</b> 12/18/2009

<b>Direction Photo Taken:</b> Northeast		
<b>Description:</b> Sampling Location WR-10

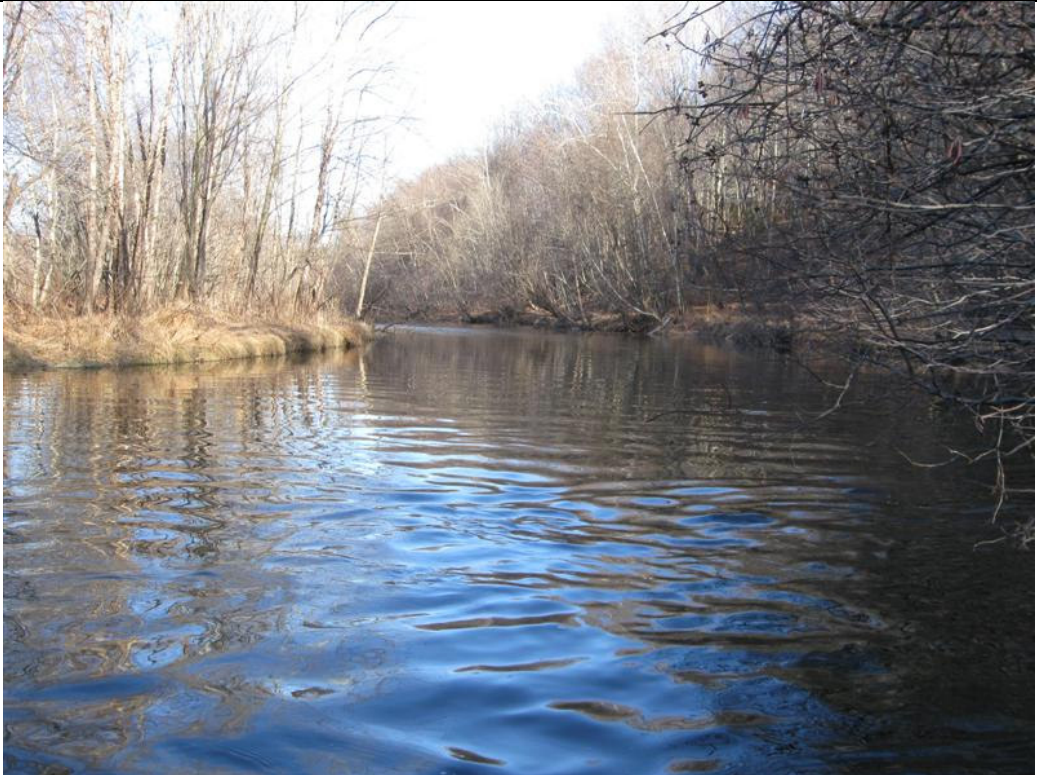
<b>Client Name:</b> DuPont		<b>Site Location:</b> Wanaque River Valley	<b>Project No.</b> 18985452
<b>Photo No.</b> 11	<b>Date:</b> 12/18/2009

<b>Direction Photo Taken:</b>  North			
<b>Description:</b>  Sampling location WR-11

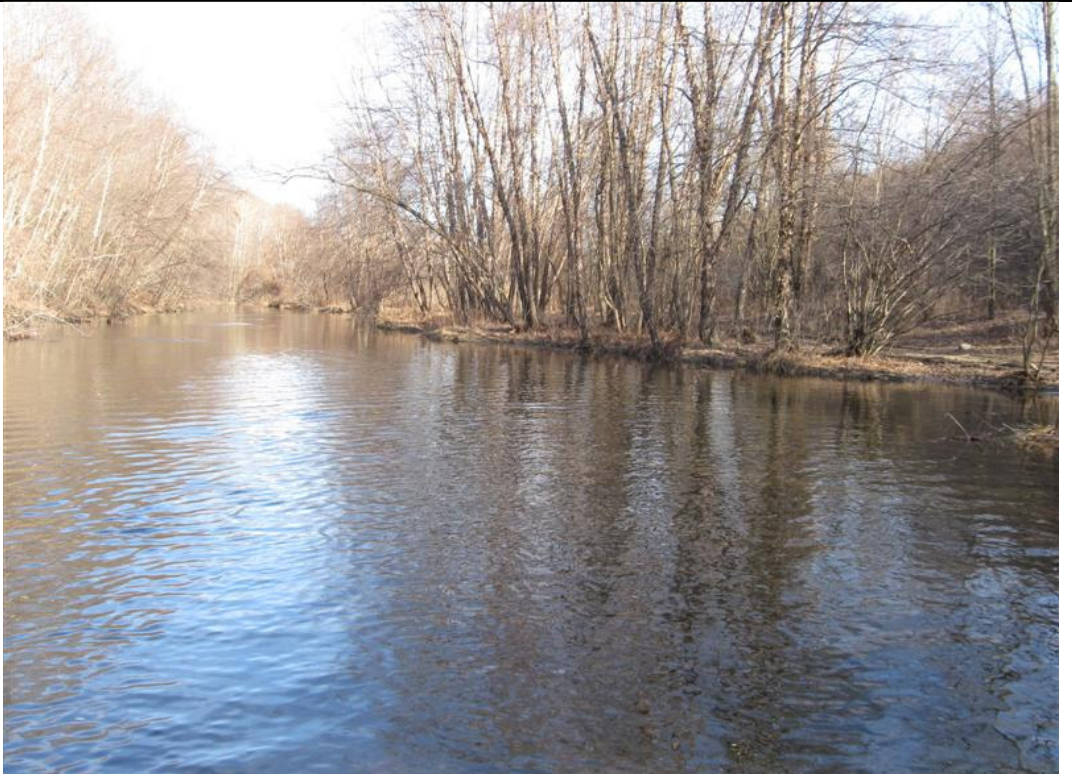
<b>Client Name:</b> DuPont		<b>Site Location:</b> Wanaque River Valley	<b>Project No.</b> 18985452
<b>Photo No.</b> 13	<b>Date:</b> 12/18/2009

<b>Direction Photo Taken:</b>  North			
<b>Description:</b>  Sampling location WR-13

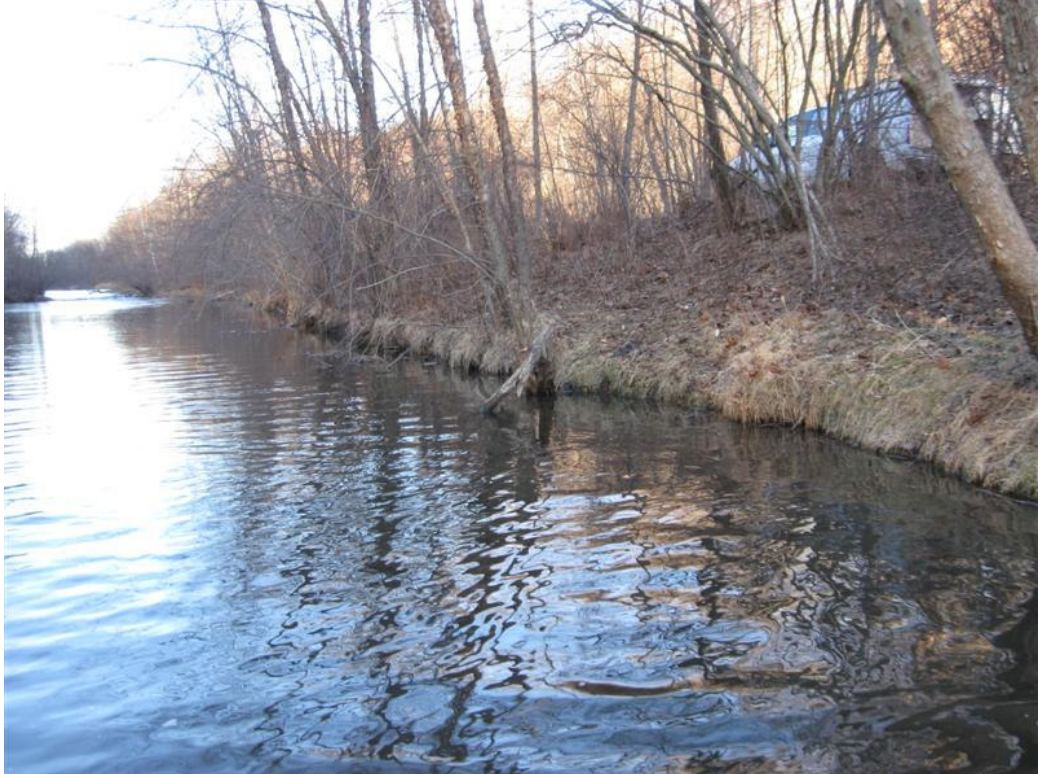
<b>Client Name:</b> DuPont		<b>Site Location:</b> Wanaque River Valley	<b>Project No.</b> 18985452
<b>Photo No.</b> 15	<b>Date:</b> 12/17/2009

<b>Direction Photo Taken:</b>  North			
<b>Description:</b>  Sampling location WR-15

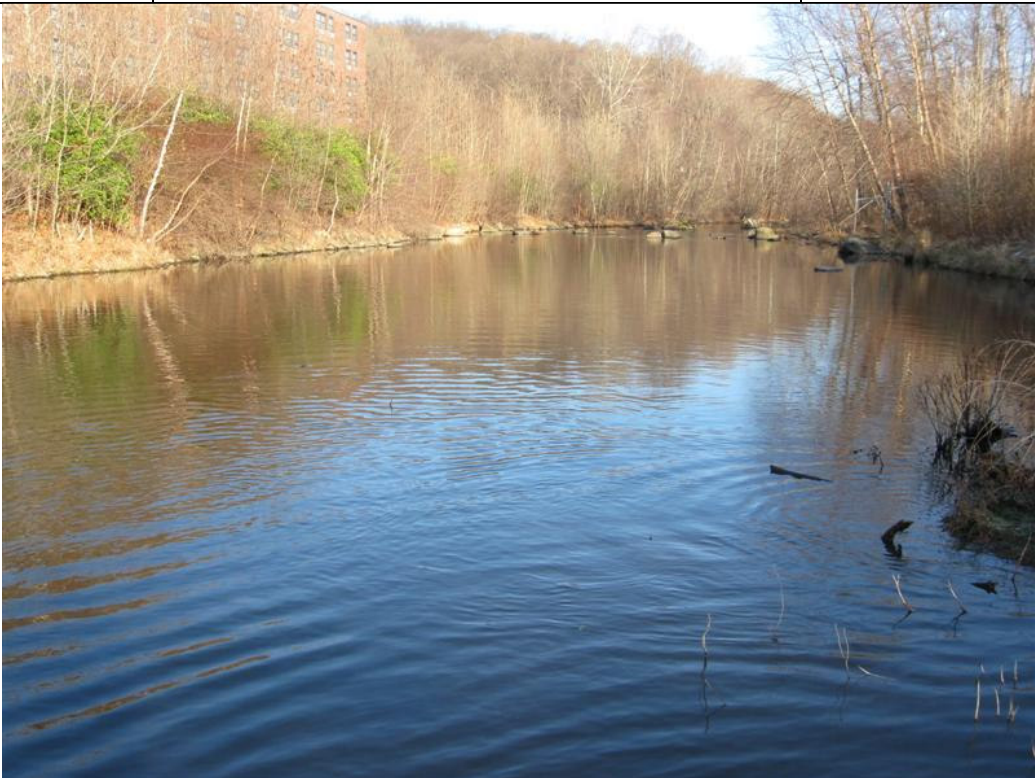
<b>Client Name:</b> DuPont		<b>Site Location:</b> Wanaque River Valley	<b>Project No.</b> 18985452
<b>Photo No.</b> 17	<b>Date:</b> 12/08/2009

<b>Direction Photo Taken:</b> North			
<b>Description:</b> Sampling location WR-17

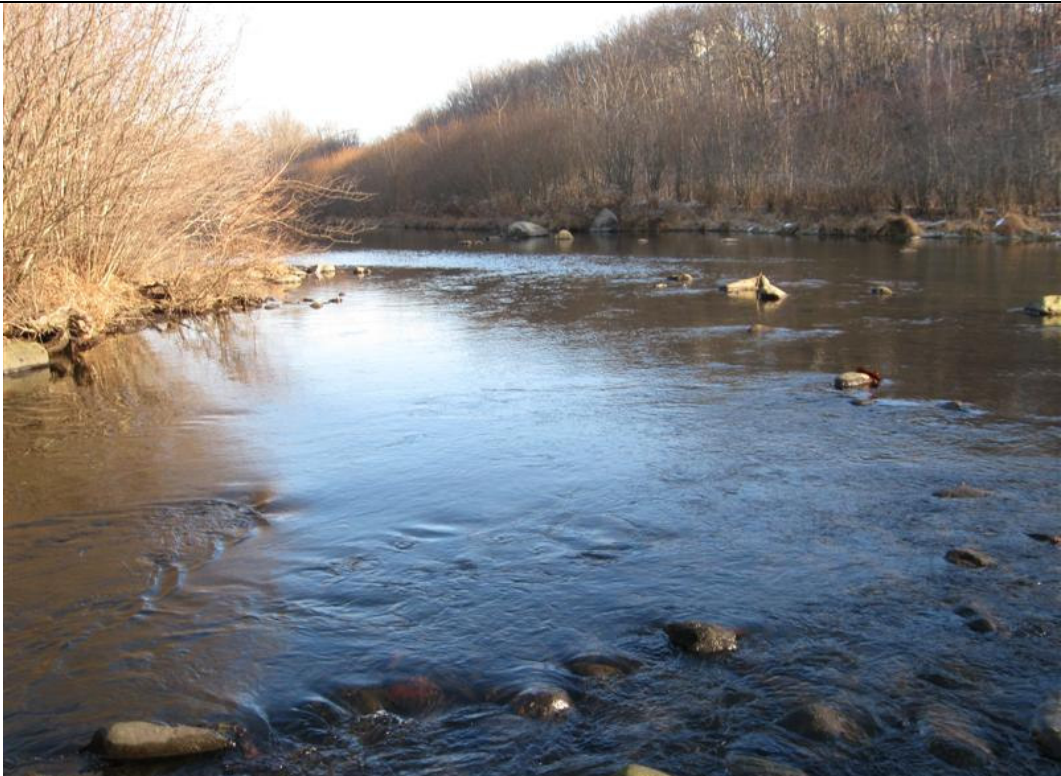
<b>Photo No.</b> 18	<b>Date:</b> 12/16/2009

<b>Direction Photo Taken:</b> North		
<b>Description:</b> Sampling Location WR-02

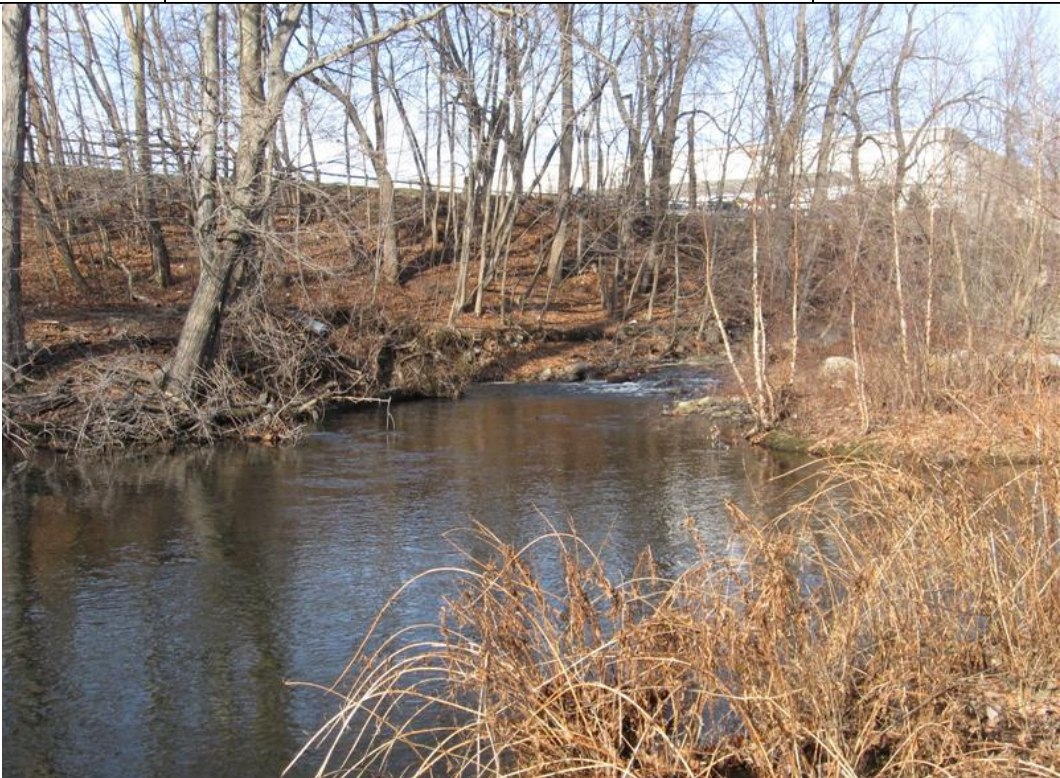
<b>Client Name:</b> DuPont		<b>Site Location:</b> Wanaque River Valley	<b>Project No.</b> 18985452
<b>Photo No.</b> 19	<b>Date:</b> 12/08/2009

<b>Direction Photo Taken:</b> North			
<b>Description:</b> Sampling location WR-19

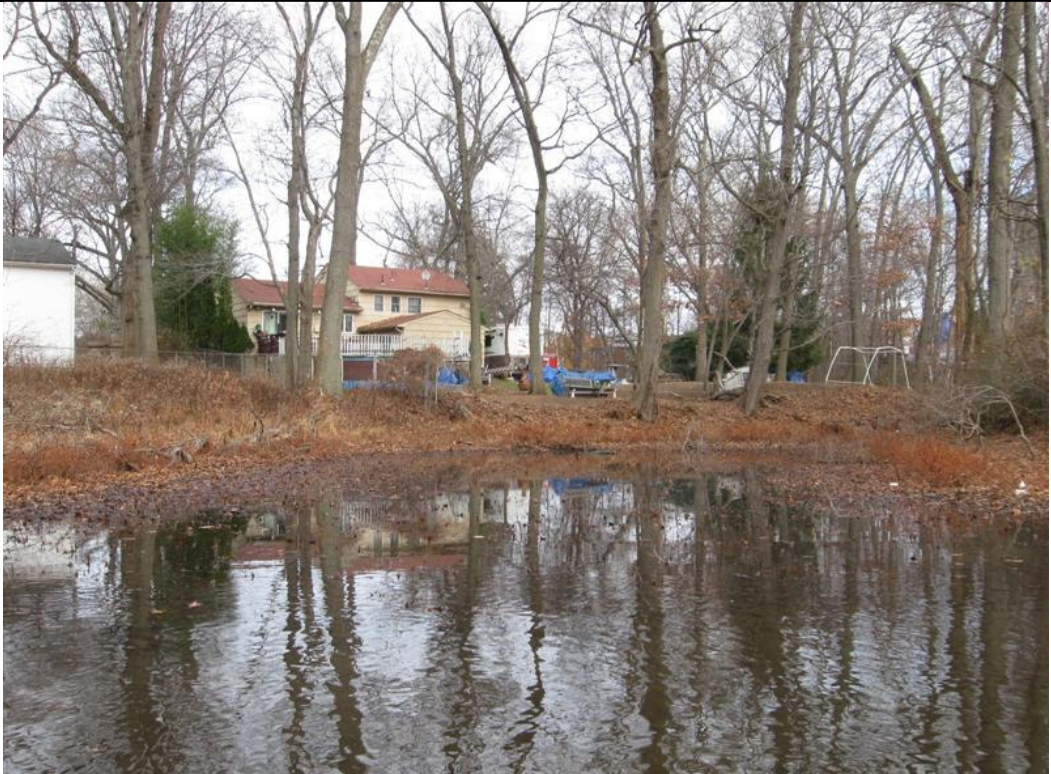
<b>Client Name:</b> DuPont		<b>Site Location:</b> Wanaque River Valley	<b>Project No.</b> 18985452
<b>Photo No.</b> 21	<b>Date:</b> 12/08/2009

<b>Direction Photo Taken:</b> North			
<b>Description:</b> Sampling location WR-21

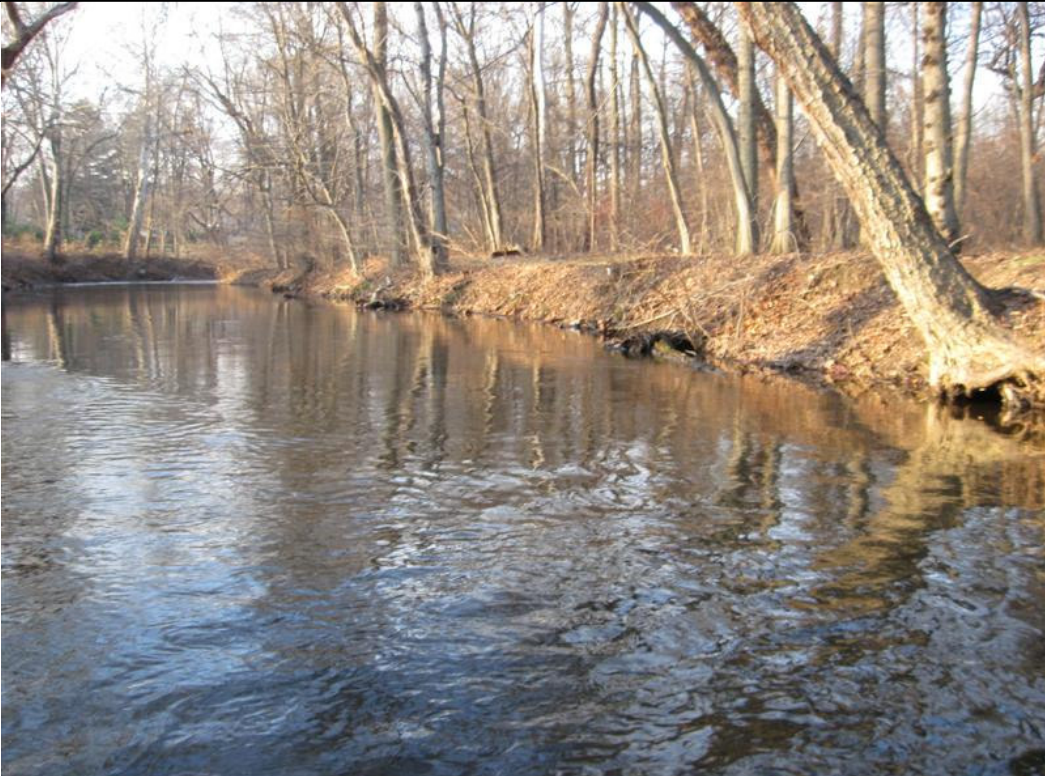
<b>Client Name:</b> DuPont		<b>Site Location:</b> Wanaque River Valley	<b>Project No.</b> 18985452
<b>Photo No.</b> 23	<b>Date:</b> 12/08/2009

<b>Direction Photo Taken:</b> North			
<b>Description:</b> Sampling location WR-23

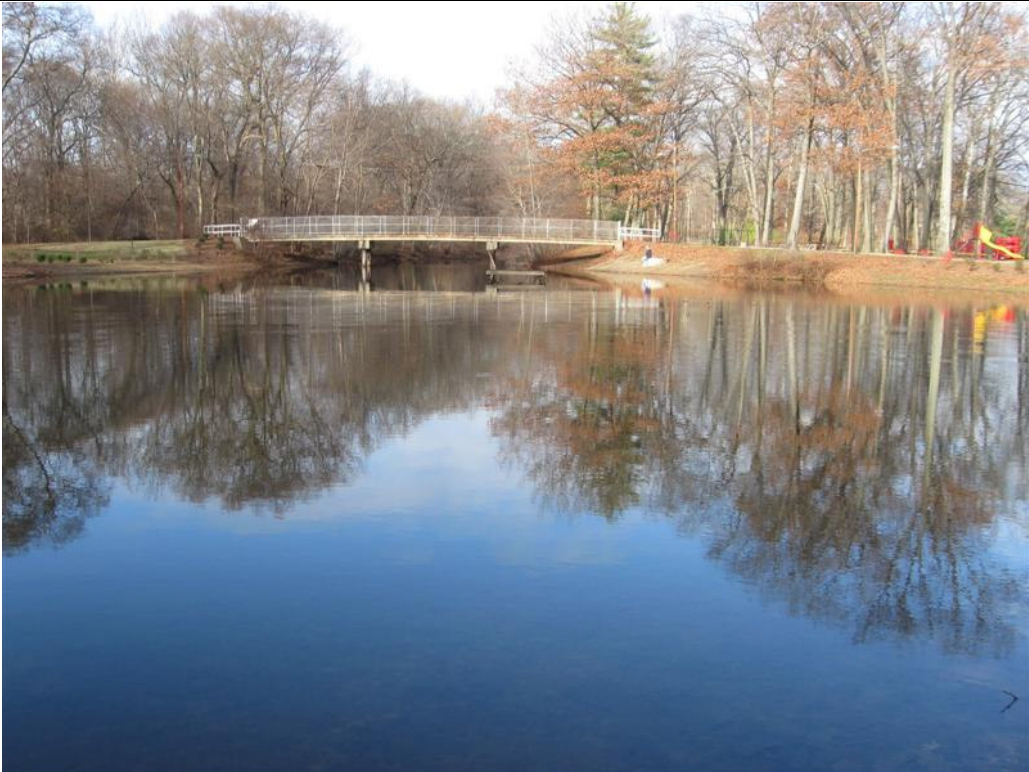
<b>Photo No.</b> 24	<b>Date:</b> 12/08/2009

<b>Direction Photo Taken:</b> North		
<b>Description:</b> Sampling Location WR-24

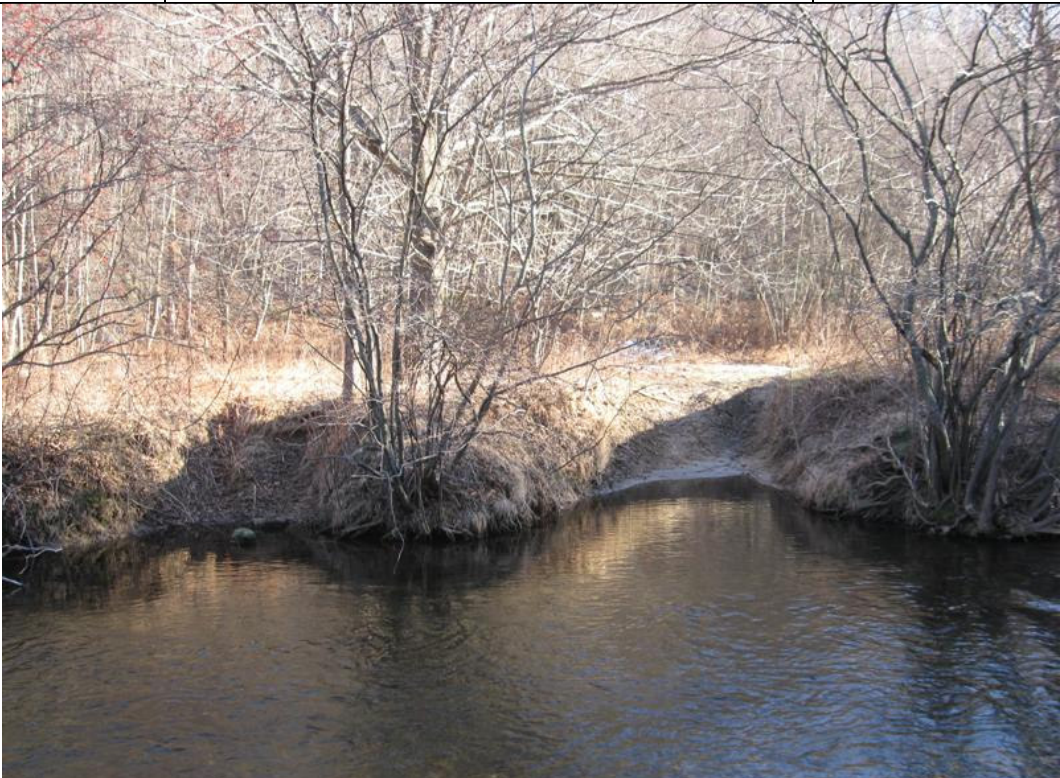
<b>Direction Photo Taken:</b>  East			
<b>Description:</b>  ATV trail within the site in the vicinity of WR-11 and WR-12.

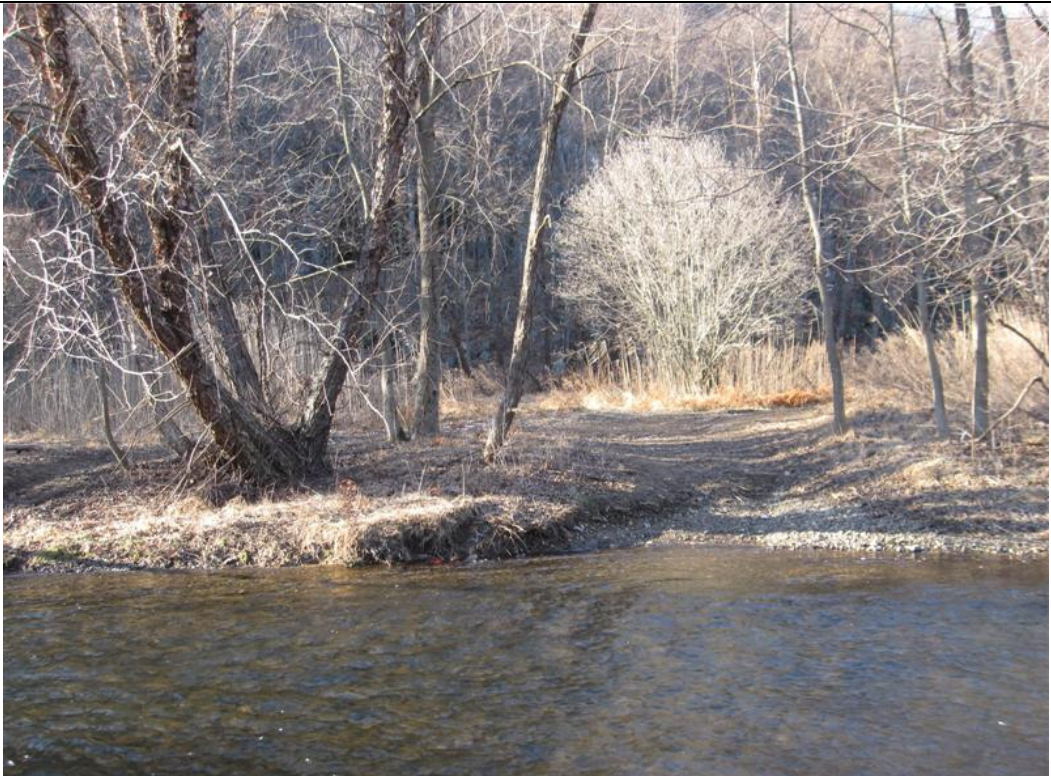
<b>Direction Photo Taken:</b>  West		
<b>Description:</b>  ATV trail within the site in the vicinity of WR-11 and WR-12.
